Memorandum

TO	Jeffrey Winick, Esq.	FROM	Scott Schneider, P.E.
COMPANY	Harris Winick Harris LLP	DATE	February 5, 2024
RE	Lakeside & Concrete Collective REA Response	PROJECT NO	NN17009.00
CC	Lori Healy, Roark Frankel, Paul Schulhof, Robert Honig, Esq.	PROJECT NAME	Obama Presidential Center

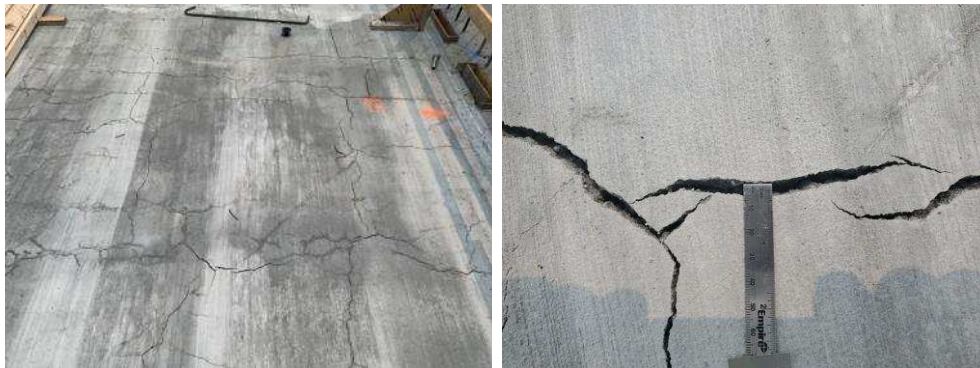
- Walls constructed with incorrect bar layering (RFI-1676).
- Incorrect installation of reinforcement of beam T-2B1 (ASI 056) and T-4B1 (RFI-2049) leading to introduction of piers.
- Failure to install bars per approved shop drawings (RFI-2771 & 2905).
- P13 library cracked slab shown below in Figure 2. Began at the end of June 2023, repairs began in November (5 months later, including incorrect repairs ignoring our guidance making the ultimate solution more difficult), still not repaired adequately after 7 months. (Observation 624).

Figure 2. Significant Cracking at P13 Library Slab Pour

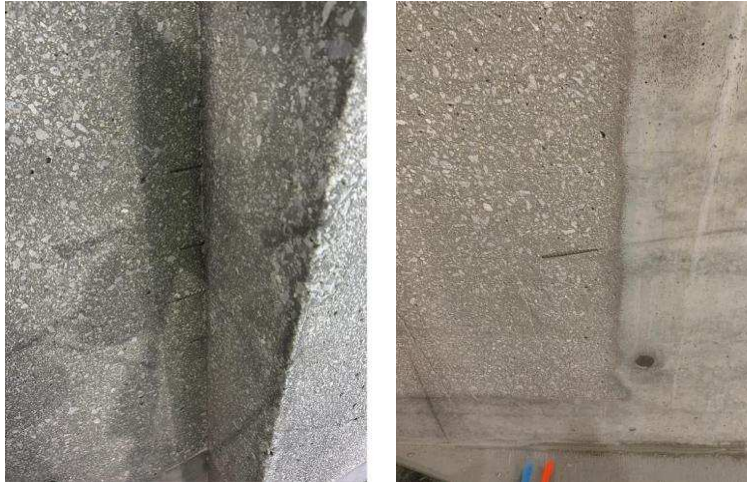
TT's structural drawings and specifications are developed to ensure structural performance as well as to align with industry standards and preferred construction methods. The leading industry organization in terms of the constructability of concrete reinforcement is the Concrete Reinforcing Steel Institute (CRSI) and their guidance on lap splices reads: *Contact Splices – in which the bars touch and are wired together – are preferred because they are more secure against displacement during construction.* TT's specification uses this guidance because we believe it improves the end work result in terms of load transfer and in terms of constructability. In our experience, contractors typically use this method to ensure reinforcement is aligned properly and secured from movement. As noted above this requirement was a part of the Construction Documents at the time of bid and could have been discussed during preconstruction. For this Project it is even more critical given the extent of architecturally exposed concrete. Poor placement, alignment, and securing of, reinforcement has led to several areas where reinforcement ended up partially exposed (as shown in Figure 3) and has required additional rework to finish these surfaces to meet the Project's architectural goals.

Figure 3. Partially Exposed Reinforcement at Architecturally Exposed Concrete Areas
